Installation Instructions

Sit-to-Stand Workstation - Antimicrobial

Wall Mounted

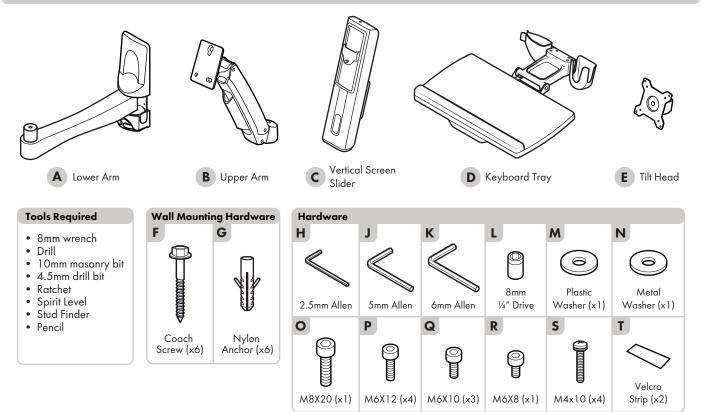
Component Checklist

Check that you have received all parts against the Component Checklist.

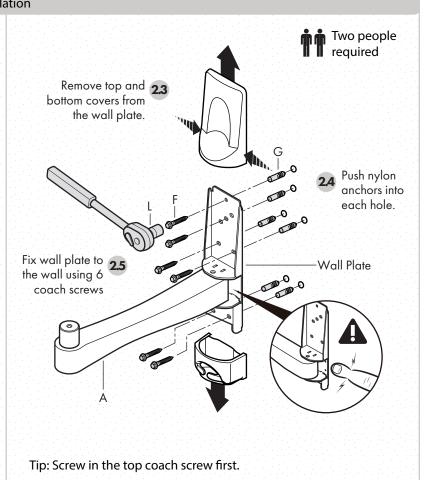
Step 2. Option A - Masonry or cement wall installation Usethesupplied template to mark and drill 6 holes into the wall. Spirit Level 2.1 Figure 1.0 Spirit Level

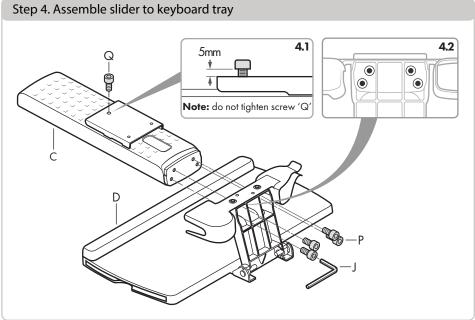
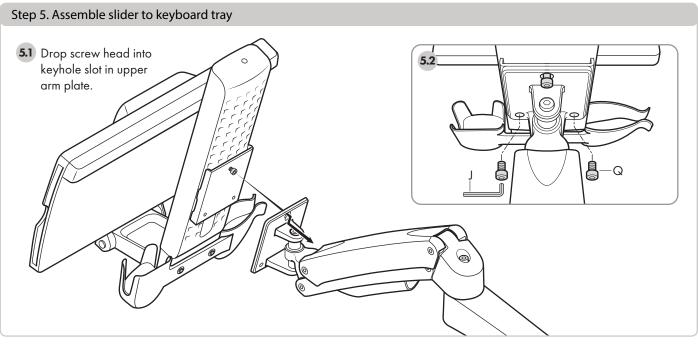
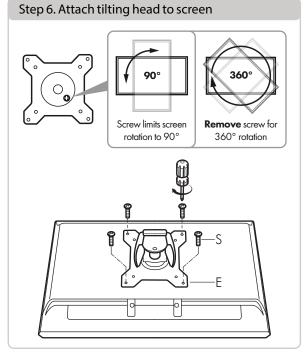
Adjusting **Screen Height Tension Screen Tilt Tension Tension Adjustment Points Keyboard Tray Storage Arm Rotation Joint Tension** The keyboard tray can be folded away for storage. Note: Supplied velcro strips secure the keyboard when stowed. **Mouse Tray Position Arm Height Tension** Note: Arm must be in highest position to access tension adjustment point.
